ALL-WEATHER  
**OUTDOOR JOURNAL**

Project Mackenzie Wood

Aug 21st 2019

Mackenzie Delta with  
Ellen & Alicia Sendrowski  
Motor boat driven by  
Greg Elias

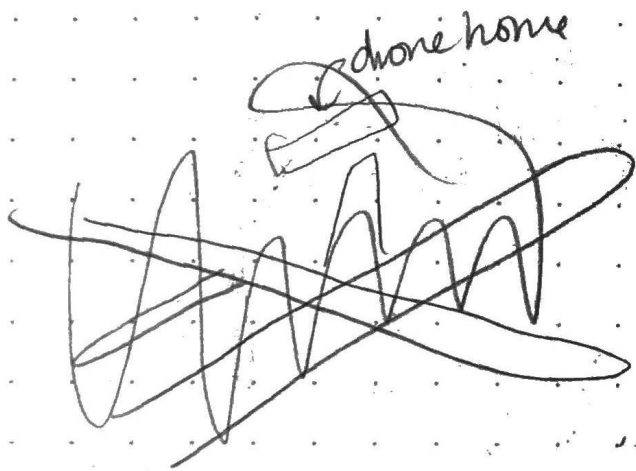
Drone flight  
near site 9  
but further upstream  
over point bar
